Mitsubishi FA Integrated Solutions: Nitto Denko Corporation, a Customer Case Study

Retrofitted modules reduce fire risk through leakage monitoring of existing installed electrical devices and wiring; safety is improved and long term maintenance cost's reduced.

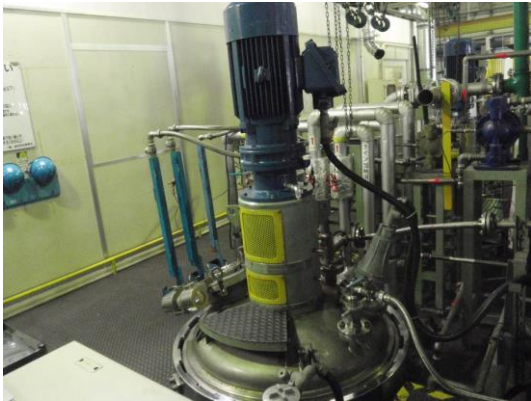
Picture 4: Production equipment at Plant 2. Fire is strictly prohibited because of the presence of flammable liquids.

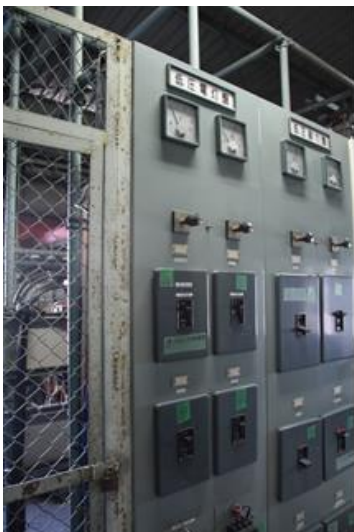
Picture 5: Many devices at Plant 2 have been used since the start of

operations over 40 years ago.

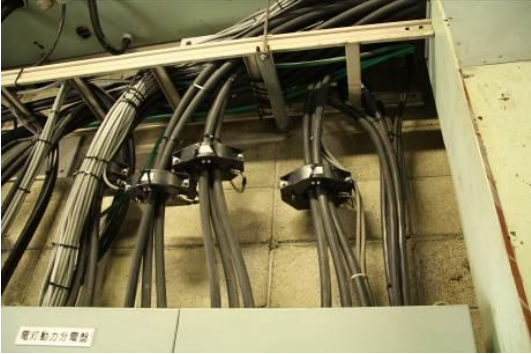
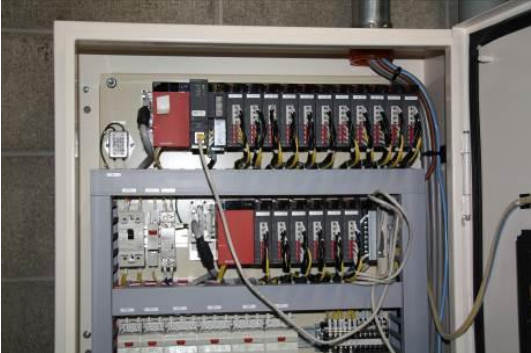
Pictures 6 and 7: The ZCT (Pic 6) mounted on the cables at the base of the panel board sends leakage current information to the insulation monitoring module “QE82LG” (Pic 7) within the panel board for processing.

Nitto placed 30 QE82LGs in the transformer room and 22 in the cubicles of its Plant 2. The Zero-phase Current Transformer (ZCT) mounted on the cables at the base of the panel board is used to send leakage current information to the QE82LG which processes it. Measurement results are displayed on the GOT (Graphic Operation Terminal) display. The QE82LG allows two types of alarm threshold value to be set; in this case Nitto set an electric-shock level of 30mA and a potentially fire causing leakage-level of 200mA. If any of the total 52 monitoring devices should exceed these levels, even once, the GOT displays the leakage point in yellow or red and emits a warning.

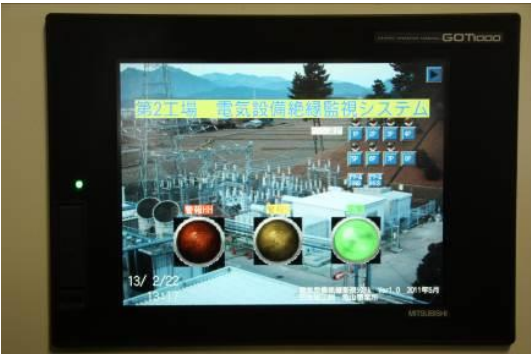
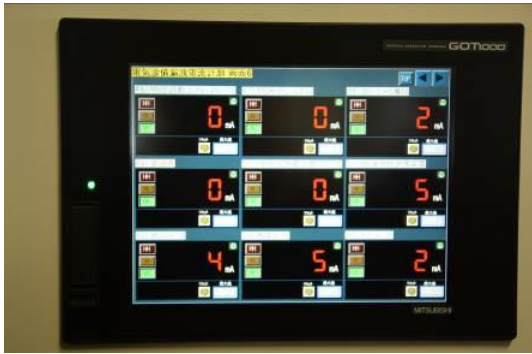
Pictures 8 and 9: Main display screen (Pic 8) and individual monitoring results display screen (Pic 9) on the GOT. Values exceeding the set threshold values light up in yellow or red.
